Technical information

Dr. Ulrich Ringleb

Burn Marks on Commutator Surfaces

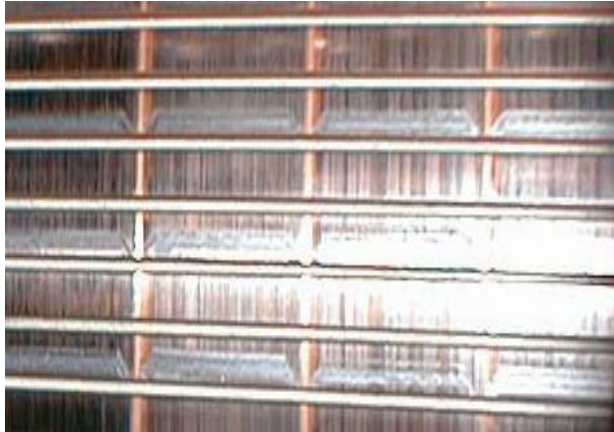
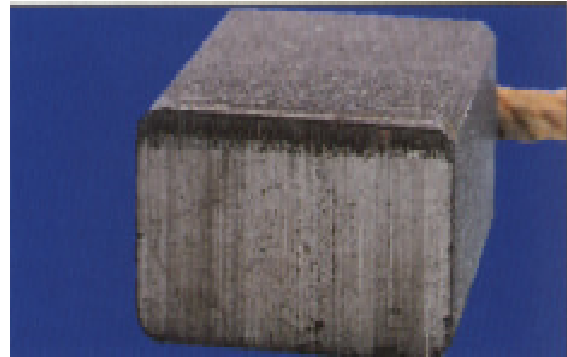
These blurs distinguish themselves significantly from all other kind of blurs, which will be described later: they are sharp-edged, overlap approximately half of the bar and are trapezoidal.

Blurs or burn marks caused by commutation problems are normally to be seen in regular distances at the trailing edge of the commutator bars. Sometimes, depending on the design of the rotor winding, every third, fourth or fifth is affected.

- Check and if applicable adjustment of the neutral zone
- Check and if applicable adjustment of the interpole (interpole air gap)
- Check of the control device
- Check of the brush grade and
- Check of the brush design

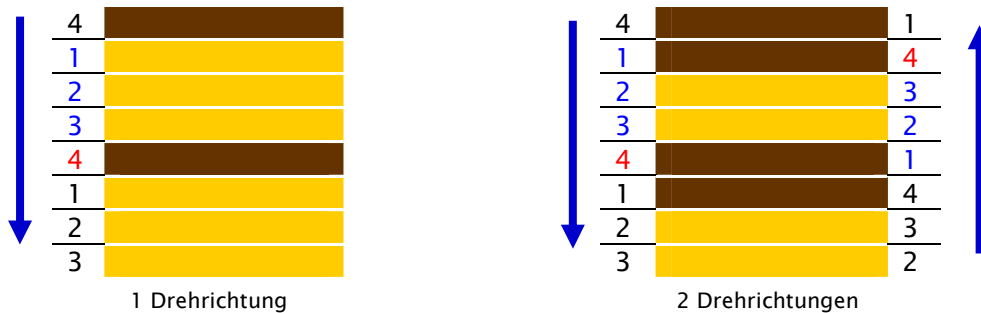
Motors with two turning directions show discolorations according to right sketch below.

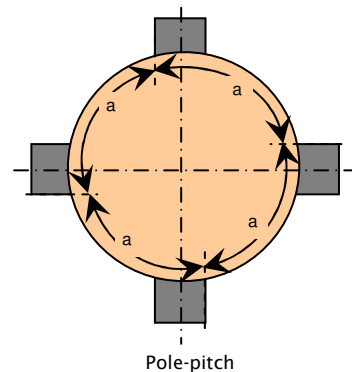
Often “commutator blurs in pole-pitch” can be observed, in an advanced state also “out-of-roundness in pole-pitch”. Pole pitch is the distance between the brush arms.

Here one bar is more burned than the adjacent one – accidentally or by means of electrical or mechanical abnormalities (e.g. by resistance differences due to unbalances in the winding, commutator deformations etc.). The current transfer at this bar is disturbed, the electrically parallel brushes of the same polarity have to transfer more current and are thereby overloaded.

Advanced burn marks in pole-pitch also appear in an out-of-roundness measurement.

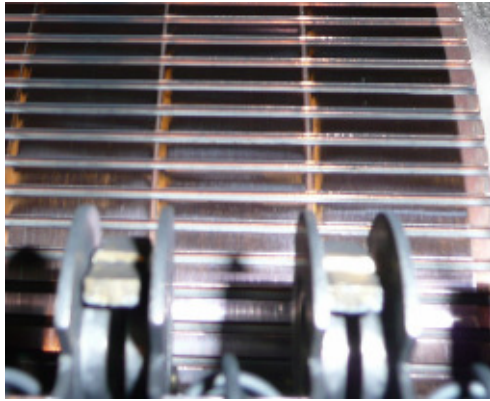
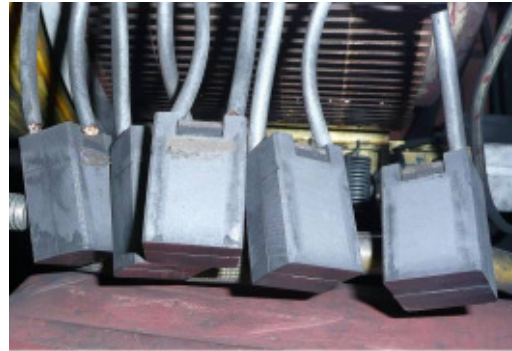
Brush sparking caused by vibrations triggers a slightly different commutator pattern. The blurs and burn marks are not sharp-edged but rather washy. The whole bar can be affected and particularly the burn marks are not regularly distributed on the commutator perimeter. (see also picture T12, T14 in the illustrations of commutator states of the well known carbon brush suppliers).

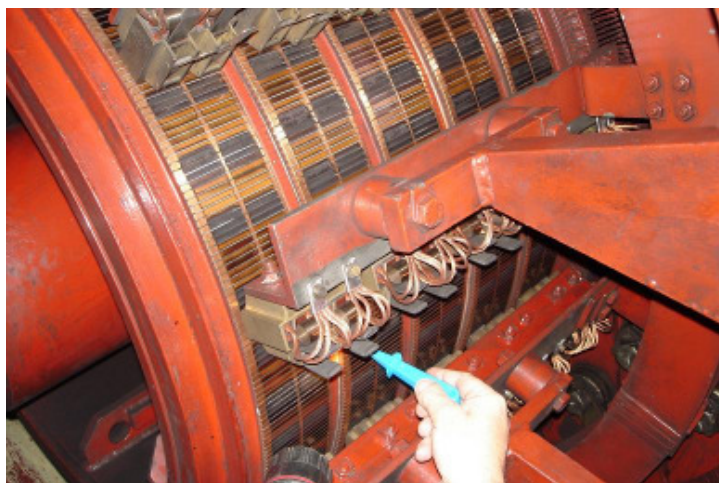
Broken commutator lead

Loosen or high resistance connections between the armature winding and the commutator bars cause burn marks, starting at the bar directly adjacent to the segment with the broken lead. The contact between brush and commutator gets worse and the whole commutator shows more and more sign of burning. In an advanced state flat spots and burn marks will show up, regularly distributed around the commutator perimeter.

Single bars with poor film formation due to reduced current flow are an indicator for broken commutator leads.

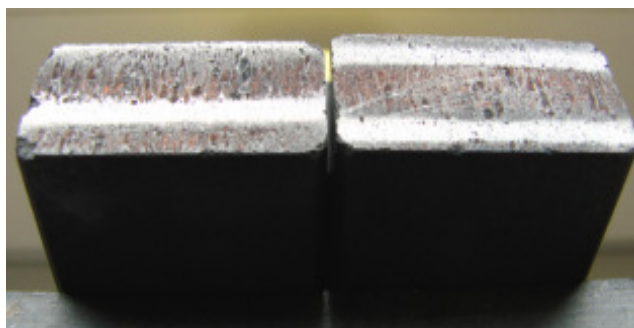
A by-product of bad commutation conditions is a special marking on the brush contact surface. The contact surface is divided in zones, each one bar width wide.

That phenomenon is caused by abnormally high current density in parts of the contact surface during dedicated phases of the commutating process.

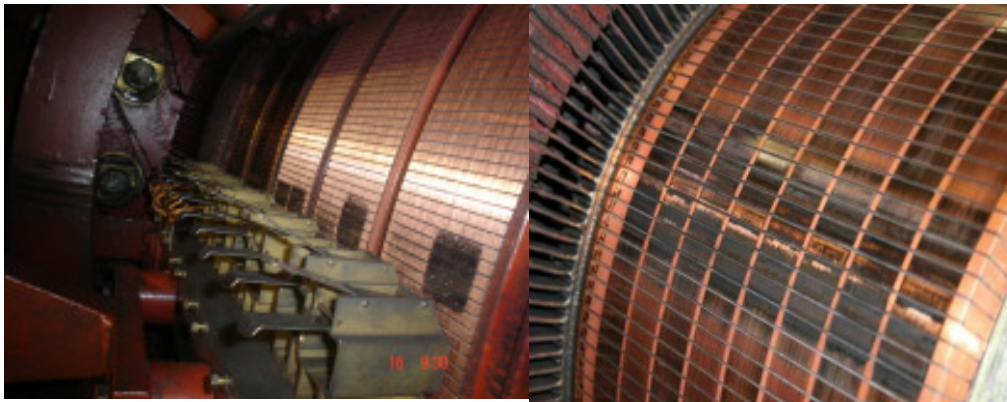
Due to the locally high temperatures in case of impermissible standstill load the copper of the commutator bar will be softened and changes its structure permanently. Thus flat spots and out-of-roundness will show up during operation.

The commutator bars will expand. Due to the arch pressure inside the commutator they will not move back to their original position while cooling down. That also causes out-of-roundness, brush vibration and further after-effects.

During standstill phases DC motors may be loaded only for a limited time to avoid damage of the commutator. At interval operation DC motor OEMs recommend a duration of max. 20 seconds at 100% overload.

It has to be considered, that standstill load in the same position of the rotor e.g. in case of restarts of blocked extruders etc. , may be repeated only, if commutator and armature are sufficiently cooled down.
