Power Plant Avoids Cost of Motor Replacement

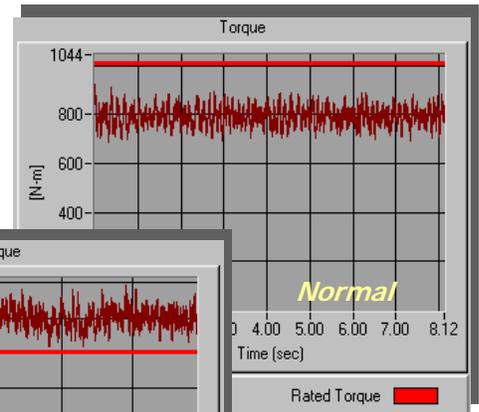
The load profile showed higher than rated values. Maintenance history research revealed that the impellor had been replaced in October 2004. It was discovered that a 17 inch impellor had been installed instead of the required 15.75 inch one. A properly sized impellor was installed, lowering the torque to the expected values.

The Instantaneous Torque graph displayed that the torque level requested by the load exceeded the rated torque for this motor.

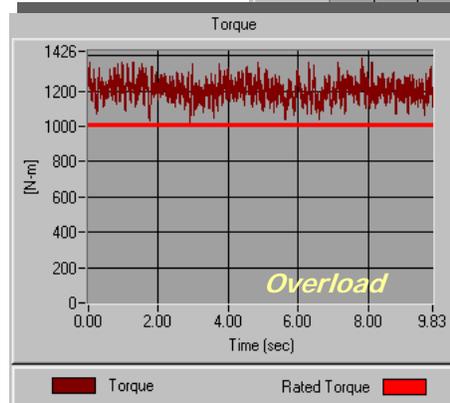
The torque levels returned to normal after replacing the incorrect sized impellor.

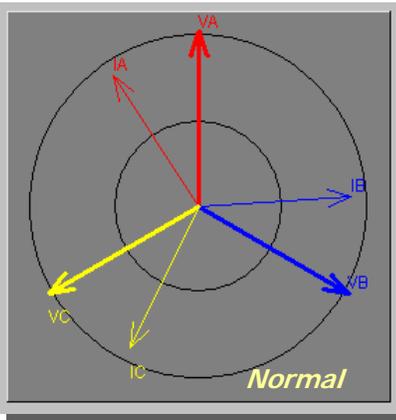
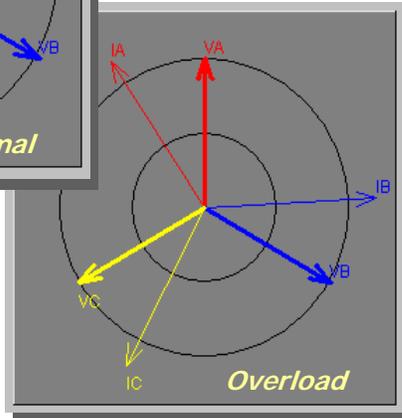
Phasor Diagrams:

The Phasor diagram of the Refuse pump showed all currents exceeding the motor's full load currents – represented by the outer circle.
