Rooftop HVAC Sustainability Test Report

Shaft Voltage Testing: Inverter Driven HVAC motors.

Application: Bearing Protection for PWM Inverter Driven AC electric motors commonly used in HVAC Systems

Purpose: Protect VFD/Inverter Driven Motors from Electrical Bearing Failure

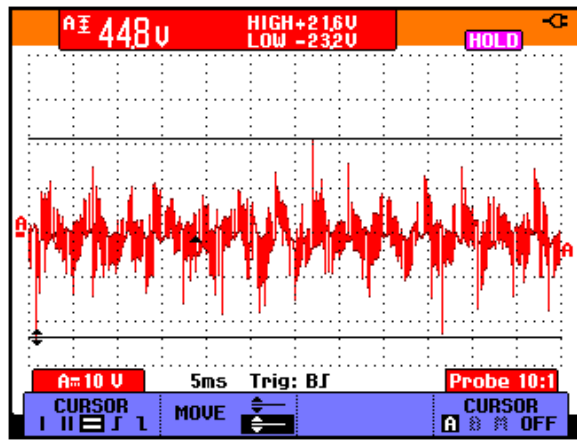
Reading 1: Shaft Voltage Reading DE

Test 2c: Shaft Voltage with NO AEGIS
Motor running at 3600 RPM

Fluke 199C Setting: 10 v/div; 5msec/div

Observations: 44.8 v pk-pk.

Continuous discharge events in 60 msec trace.

Voltage is breaking down with EDM currents discharging in bearings.

The higher speed at 80 Hz create both higher pk-pk voltage and much greater number of discharges during the same time frame.

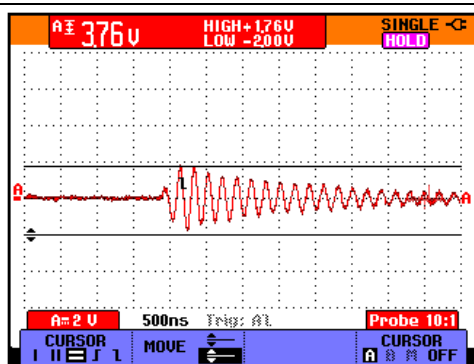
Test 3b Reading 2:

Motor running at 1800 RPM
Shaft Voltage Reading DE

Fluke 199C Setting: 2 v/div; 500µsec/div

Observations: 3.76 v pk-pk. Note ringing effect of voltage wave form. This waveform is typical of VFD ground noise. Voltage discharge takes place at fiber tips.
