Power Plant Avoids Cost of Motor Replacement

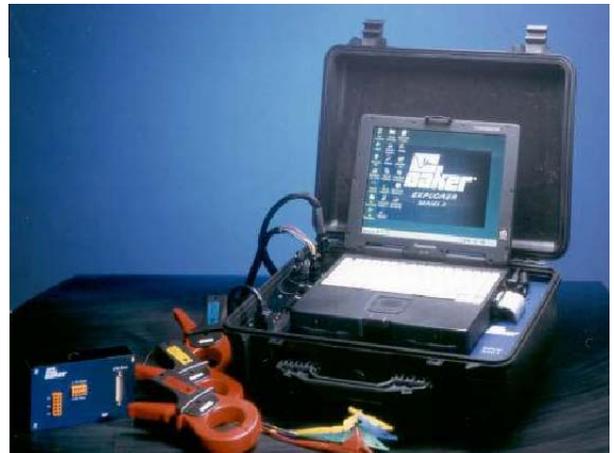
Phasor Diagrams:

The Phasor diagram of the Refuse pump showed all currents exceeding the motor's full load currents – represented by the outer circle.
